DRYZONE[®] DAMP-PROOFING CREAM

The World's Most Rigorously
Tested Rising Damp Treatment

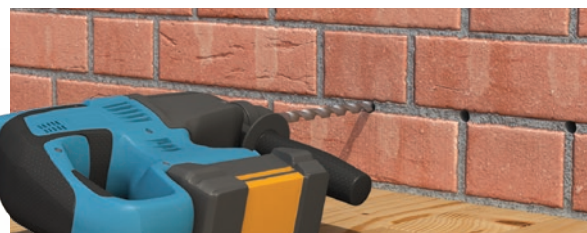
1. Drilling

First create a series of horizontal drill holes along the mortar course. Typically these are 12 mm holes at 120 mm intervals – refer to the **Dryzone®** application instructions for details for particular wall thicknesses.
